Manhole Inspection Summary

Manhole # S31C__031MH

Location Address: **REAR OF 415 PACA ST**

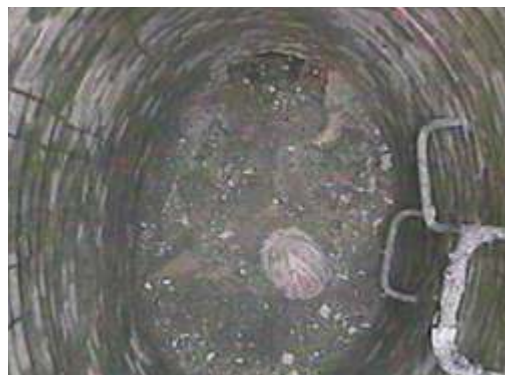
Top View

Count: **6** Missing: **0** ☒ **Corroded**

CORRODED STEPS

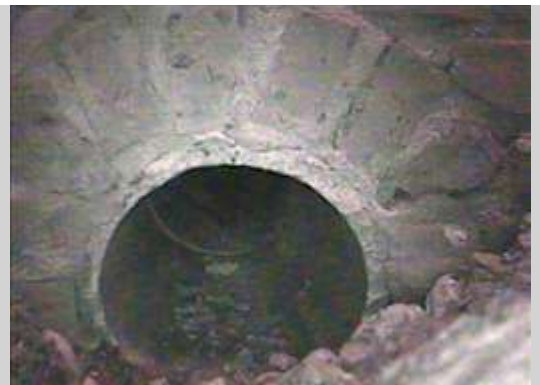
12 O'Clock Outflow

8 in. Circular Gravity Sewer
Pipe Out @ 12 O'Clock

Deposits: ☐ None ☒ **Mud** ☐ Sludge ☒ **Debris** ☐ Grease

Silt Depth: **0.5** (in.) Deposits Extent: **Light**
